**Seismic Analysis of a Retrofitted Reinforced Concrete Building in
Mexico City**

Thesis

The University of Texas at Austin

August 2019

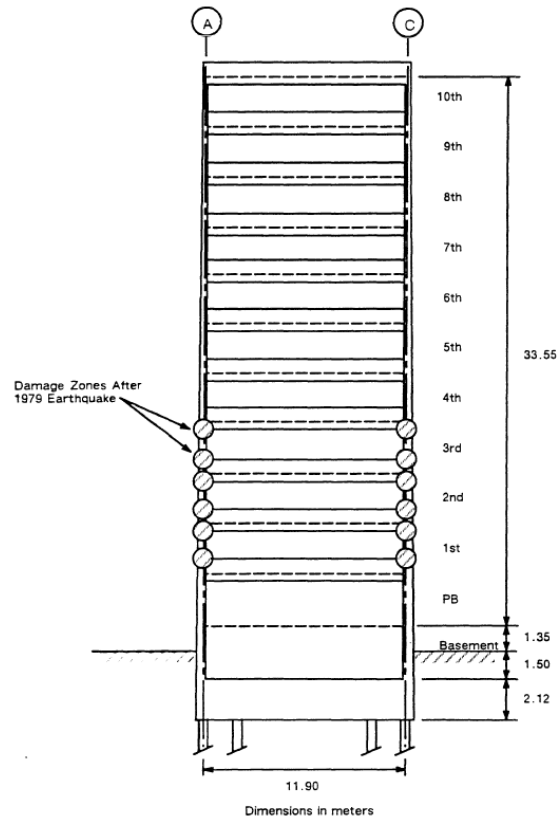
The Durango building suffered damage from a 7.6 magnitude earthquake on March 14, 1979. The damage was concentrated in stories 1 through 3 and was caused by the E-W (transverse) shaking of the building. The exterior frames (1 and 5) suffered from cracking and spalling of the beam-column connection in these levels (Fig. 2.12). Additionally, the deep spandrels experienced diagonal cracking over most of its length due to shear and flexural effects. Most of the columns had some degree of cracking in the lower

level but column B-3 also experienced crushing. This was later attributed to construction problems rather than a deficient seismic design (Downs, et al., 1991).

Figure 2.12: Damage zones of Frame 1 after the 1979 earthquake (Downs, et al., 1991)

The reason for the concentration of the damage in these areas is most likely the higher stiffness of Frames 1 and 5. This due to the short column effect, caused by the deep spandrels, which was not accounted for given the available tools and standard procedures at the time of design (Downs, et al., 1991). The result was an increase of the forces resisted during an earthquake and the concentration of these forces in these two frames, given their higher stiffness when compared to Frames 2 through 4.

Damaged elements of the existing structure were repaired before the retrofit systems were installed. Cracks were filled with epoxy, and a steel jacket was added to the columns of Frames 1 and 5 up to the 4th story. The jacket consisted of 1/2" A36 steel plates welded together to form a box around the column. Additionally, #8 rebars were welded in the interior of the plates, and the voids between the plates and the previously chipped column were filled with expansive mortar. All this to improve the bond between the jacket and the existing structure.

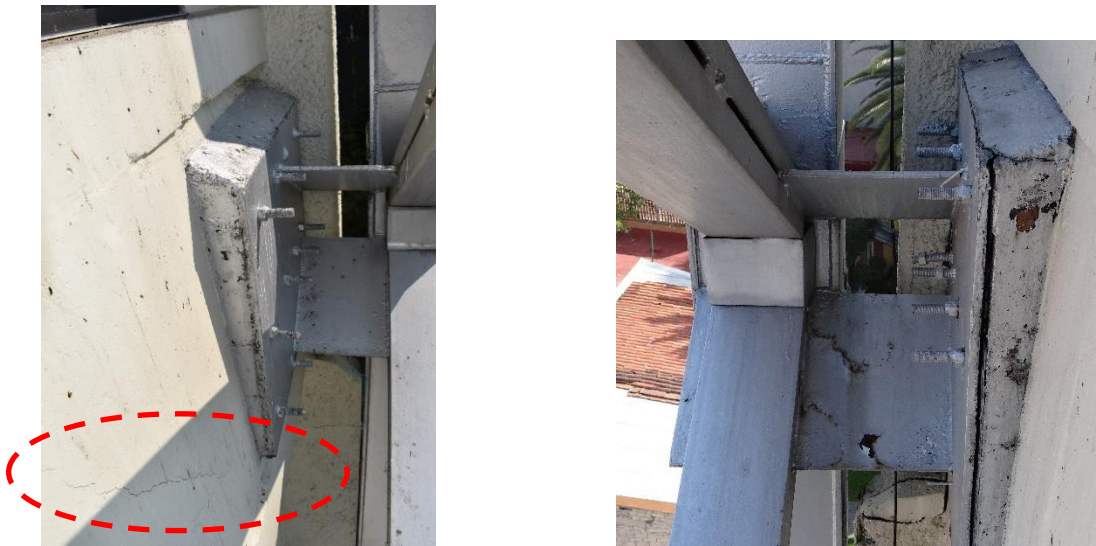
earthquake. Inclined cracks were observed in the spandrel beams at the connection with the steel bracing (Fig. 2.19). A few connections also showed loosened bolts and gaps between the steel plate and the spandrel (Fig. 2.19a). However, it is possible that those damages were previous to this earthquake. The building was also reported to lean 231 mm (~9.1 in) or 0.006% of the height of the building in the E-W direction and 150 mm (~5.9 in) or 0.004% of the height of the building in the N-S direction after the earthquake.

Figure 2.19: Cracking of spandrel beam at the connection with the steel frame (left) and loosened bolts and gap in connection between RC and steel frame (right)

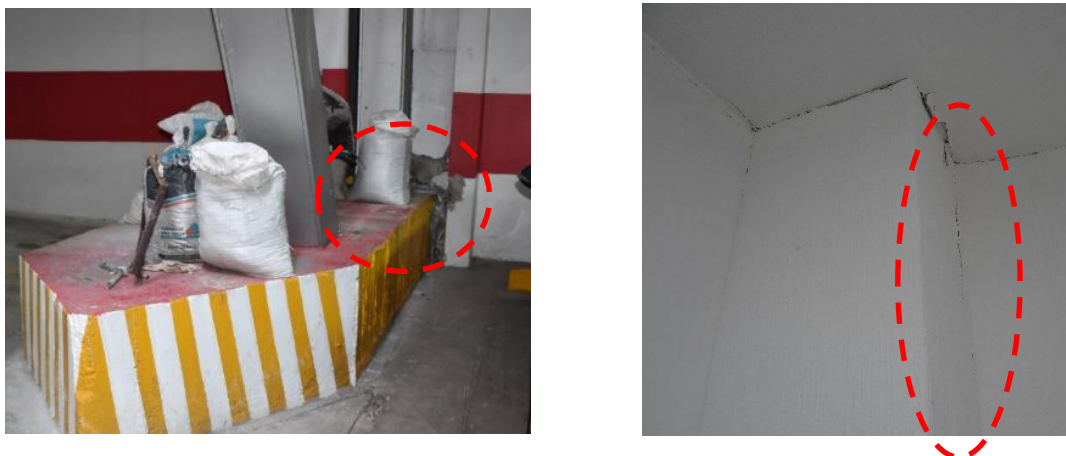
As a result of the building leaning and shaking, elements of the parking structure were damaged due to the lack of gap. Other non-structural damages were observed, such as the cracking in walls partition and the stairway walls (Fig 2.20).

Figure 2.20: Steel frame footing with the damage to adjacent parking structure (left) and crack in partition walls (right)

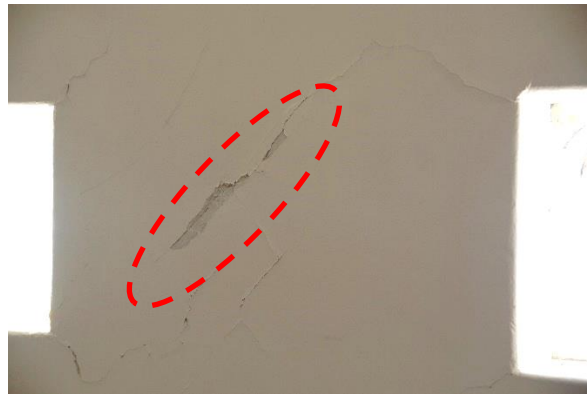
Figure 4.4: Damage to masonry wall from September 19th, 2017 earthquake

These important differences in fundamental frequencies and the damage observed in some masonry walls mentioned earlier in this chapter confirm the assumption that the masonry walls participate in the overall building response.
